Launching The Vasa

A lot rode on the men who were building the Swedish gunship *Vasa*, in 1626, and those who would sail her. It had been a calamitous decade for the Swedish Navy. A dozen of Sweden's largest warships had been captured, wrecked, or scuttled; a violent storm in 1625 had destroyed 10 of those ships, prompting the imperious King Gustav II Adolf to order four new ones. Further losses had dramatically increased the King's impatience with his shipbuilders. See **Figure 1** for an artist's rendition of the launching of the *Vasa*.¹

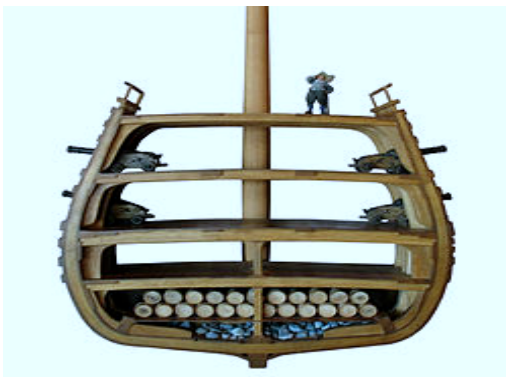
The shipbuilders added a fourth scarf to lengthen the keel, but the result was narrow in relation to its length and the draft very shallow for a ship of that size. A foot and a half was added to the beam, the widest part of a vessel, but because the keel (backbone of the vessel) was already laid it had to be added to the uppermost part of the ship. This raised the center of gravity and contributed to the ship's instability. The shallow keel did not allow sufficient room for the ballast needed to stabilize a ship of that size, and the narrow beam required extra bracing timbers, further reducing room for the ballast. See **Figure 2** for a model of *Vasa*'s hull.

Figure 2: Model of the Vasa's Hull Profile, Showing Shallow Keel and Two Gun Decks. Credit: Vasa Museum.

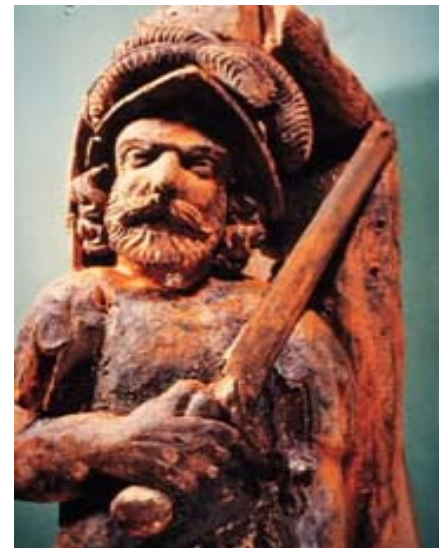
ornate carving recovered from the *Vasa*. Meant to outshine the Danish ship, no cost was spared, and the *Vasa* became the most expensive ship of its time.

Also adding to the top-heavy condition, hundreds of ornate, gilded, and painted carvings made of heavy oak were also ordered by the King. See **Figure 3** for an

Figure 3: Recovered Oak Carving. Source: Vasa Museum.

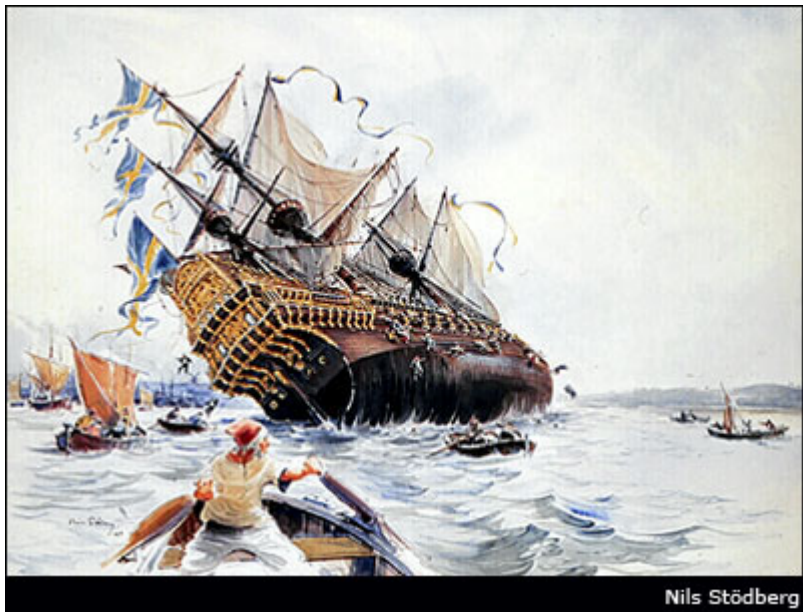
Figure 4: Recreation of the *Vasa* Capsizing. Source: *Vasa Museum*.

Most of the seamen who boarded remarked on the instability of the ship. A few sails are raised just as a light breeze picks up to fill them. The breeze fills the ship's sails and lifts spirits. The *Vasa* sails about 1,000 yards, heels over, and sinks in view of the entire crowd of spectators. Fifty souls are lost, along with the entire ship. See **Figure 4** for an artist's rendition of the *Vasa* capsizing.
